Manhole Inspection Summary

Manhole # S21E1_026MH

Insp Date: **5/22/08 9:06 AM**

Location Address: **2322 atlantic av** Cross Street: **paca-ridgely alley**

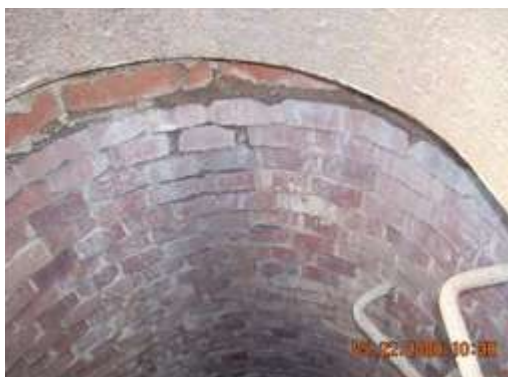
Defect 3

Infiltration: ☐ None ☒ **Joint** ☐ Cracks ☐ Mortar ☐ Roots ☐ Wall

infiltration @ chimney/frame joint

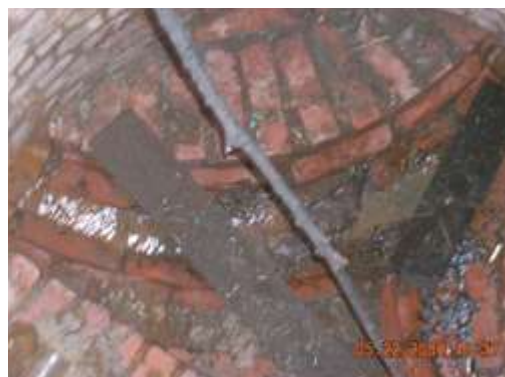
Defect 2

debris in channel and on bench

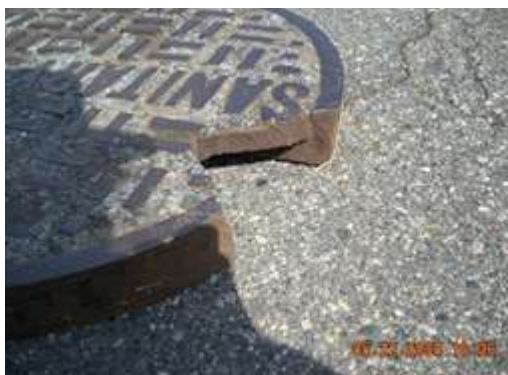
Defect 1

Type: **Sanitary** Condition: **Broken** Cover Material: **Cast Iron**

broken cover

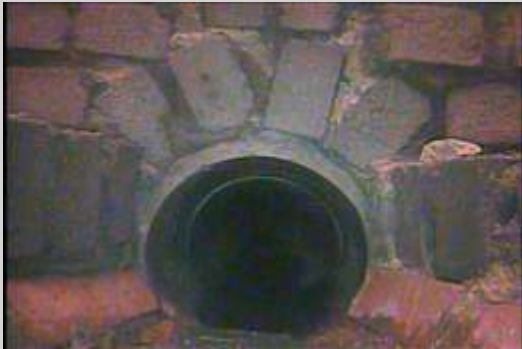
12 O'Clock Outflow

Pipe Height: **8.4** (in.) Rod and Bar (Angled)
Pipe Material: **Clay** ☐ Pipe Lined
Invert Depth: **8.15** (ft.) Flow Characteristics: **Slow**
Deposits: ☒ None ☐ Mud ☐ Sludge ☐ Debris ☐ Grease
Silt Depth: **0** (in.) Deposits Extent:
Infiltration: **None** Pipe Seal Cond: **Sound**

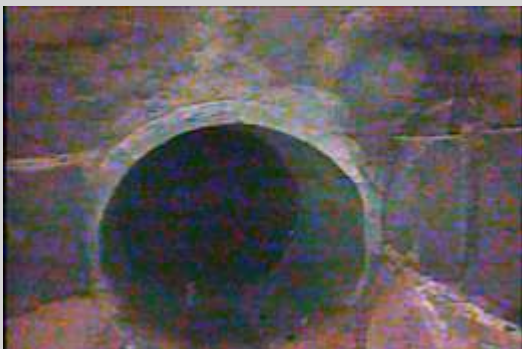
3 O'Clock Inflow

Pipe Height: **8.4** (in.) Rod and Bar (Angled)
Pipe Material: **Clay** ☐ Pipe Lined
Invert Depth: **7.89** (ft.) Flow Characteristics: **Slow**
Deposits: ☒ None ☐ Mud ☐ Sludge ☐ Debris ☐ Grease
Silt Depth: **0** (in.) Deposits Extent:
Infiltration: **None** Pipe Seal Cond: **Sound**

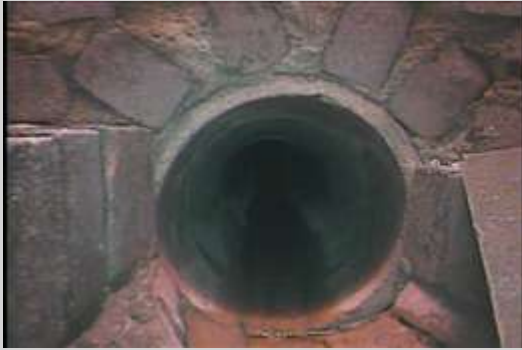
9 O'Clock Inflow

Pipe Height: **8.4** (in.) Rod and Bar (Angled)

Invert Depth: **7.70** (ft.) Flow Characteristics: **Slow**

Infiltration: **None** Pipe Seal Cond: **Sound**
